Architectural and Historic Resource City of Santa Barbara

County Bowl
 Parking Lot

3. Address: 1110 N. Milpas Street

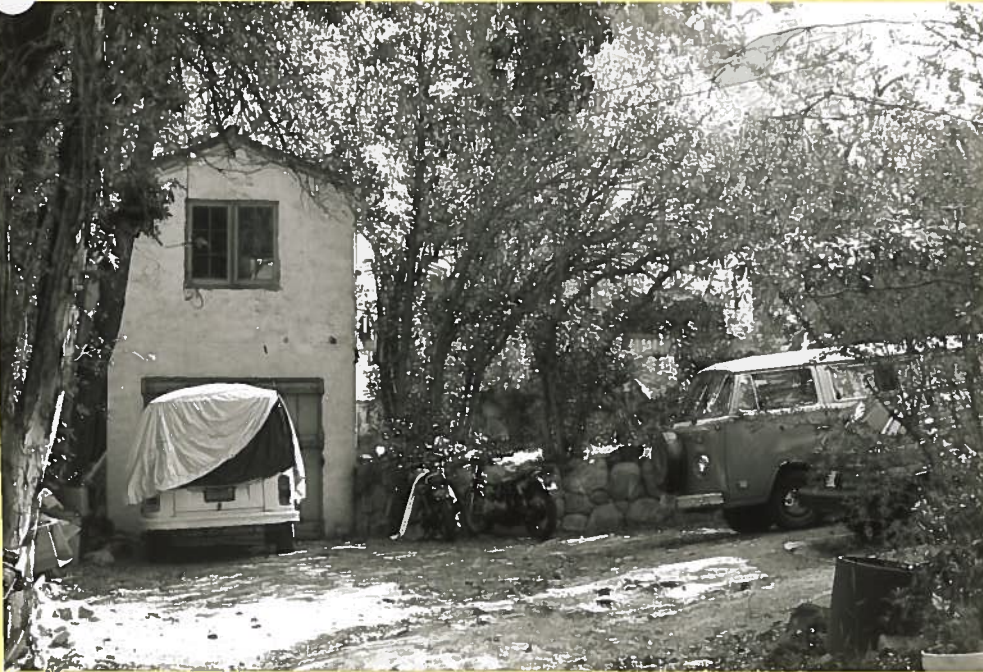
Direction: N NE S SW W NW
 Photographer: KM
 Date:
 Number: 4-23

This is a two story stucco house with a low gable tile roof. On the right rear side is a narrow arched entryway. The building is situated on an upper terrace reached by stone steps bordered by an old stone wall. There is a one story wing on the left. In front is an extension with a shed roof and aluminum framed sliding doors. Paired casement windows are above and below.

3. Condition of exterior: Excellent _____ Good x Fair _____ Deteriorated _____

4. Apparent additions or alterations, if any:
Sliding doors & windows
