Architectural and Historic Resource City of Santa Barbara

County Bowl
 Parking Lot

3. Address: 1110 N. Milpas Street

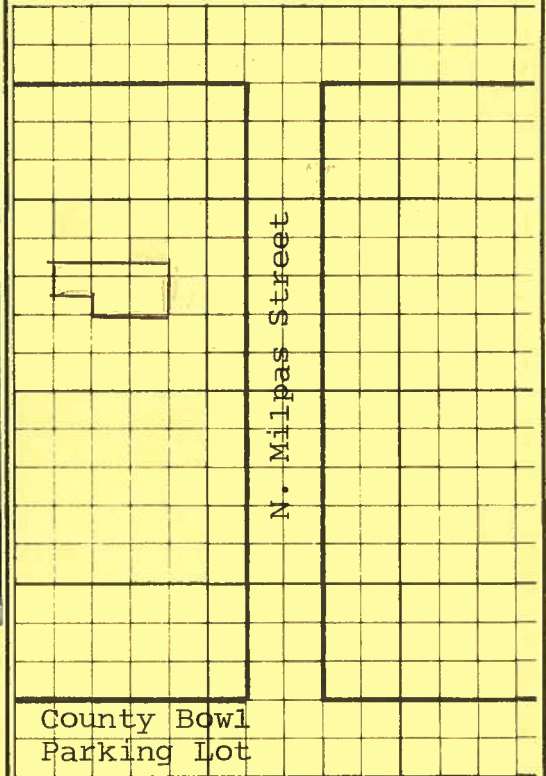
Direction: N NE S SW W NW
 Photographer: KM
 Date:
 Number: 4-23

3. Condition of exterior: Excellent _____ Good x Fair _____ Deteriorated _____
